Groundwater Monitoring Evaluation
~~Pine Bluff Arsenal~~ (PBA)
Pine Bluff, Arkansas
EPA I.D. NO. AR0213820707

December 16, 1985

SUMMARY

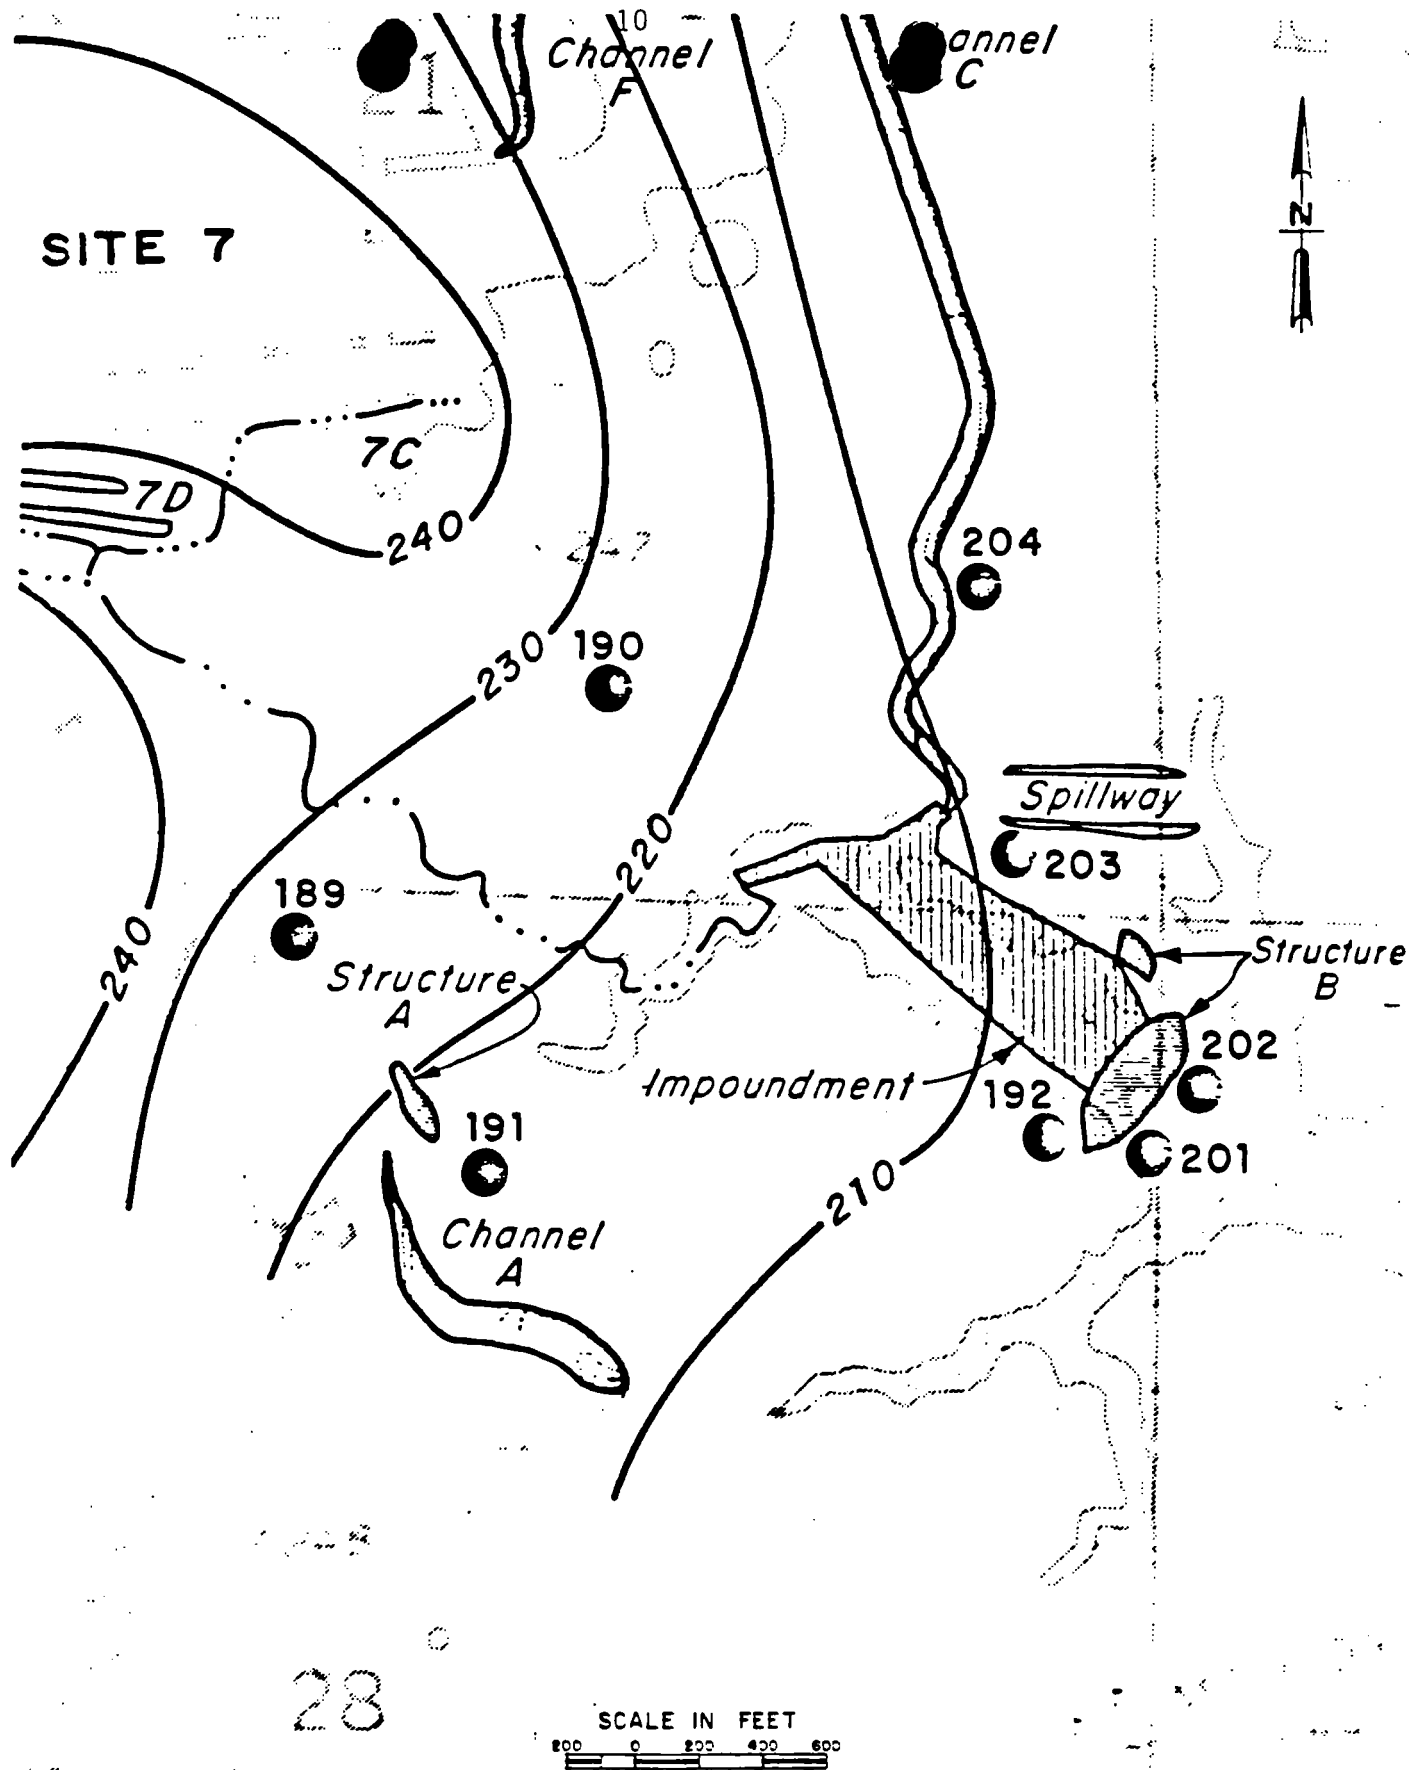
Figure 4. Impoundment monitoring wells and water table (based on December, 1984 readings)

The total organic carbon (TOC) levels in Well 201 were relatively high compared to the other wells. The March 1985 values for Well 201 was 18.0 and the values of the other wells ranged from 2.5 - 4.9. The total organic halogen (TOX) levels in Well 203 were relatively high (1.570 mg/l - 1.750 mg/l) compared to the other wells (0.028, 0.093).

High levels of TOX in Well 203 were reportedly due to the presence of chloroform and chlorobenzene. Chlorobenzene measured 160 ug/l in Well 203 but was below detectable limits (5.0 ug/l) in all of the other wells. PBA reports that chlorobenzene is the result of the DDT operations.

The surface run-off control impoundment site should be moved into the assessment phase of groundwater monitoring to determine the extent of the groundwater contamination which could be emanating from Site 7, 11, or another PBA site.

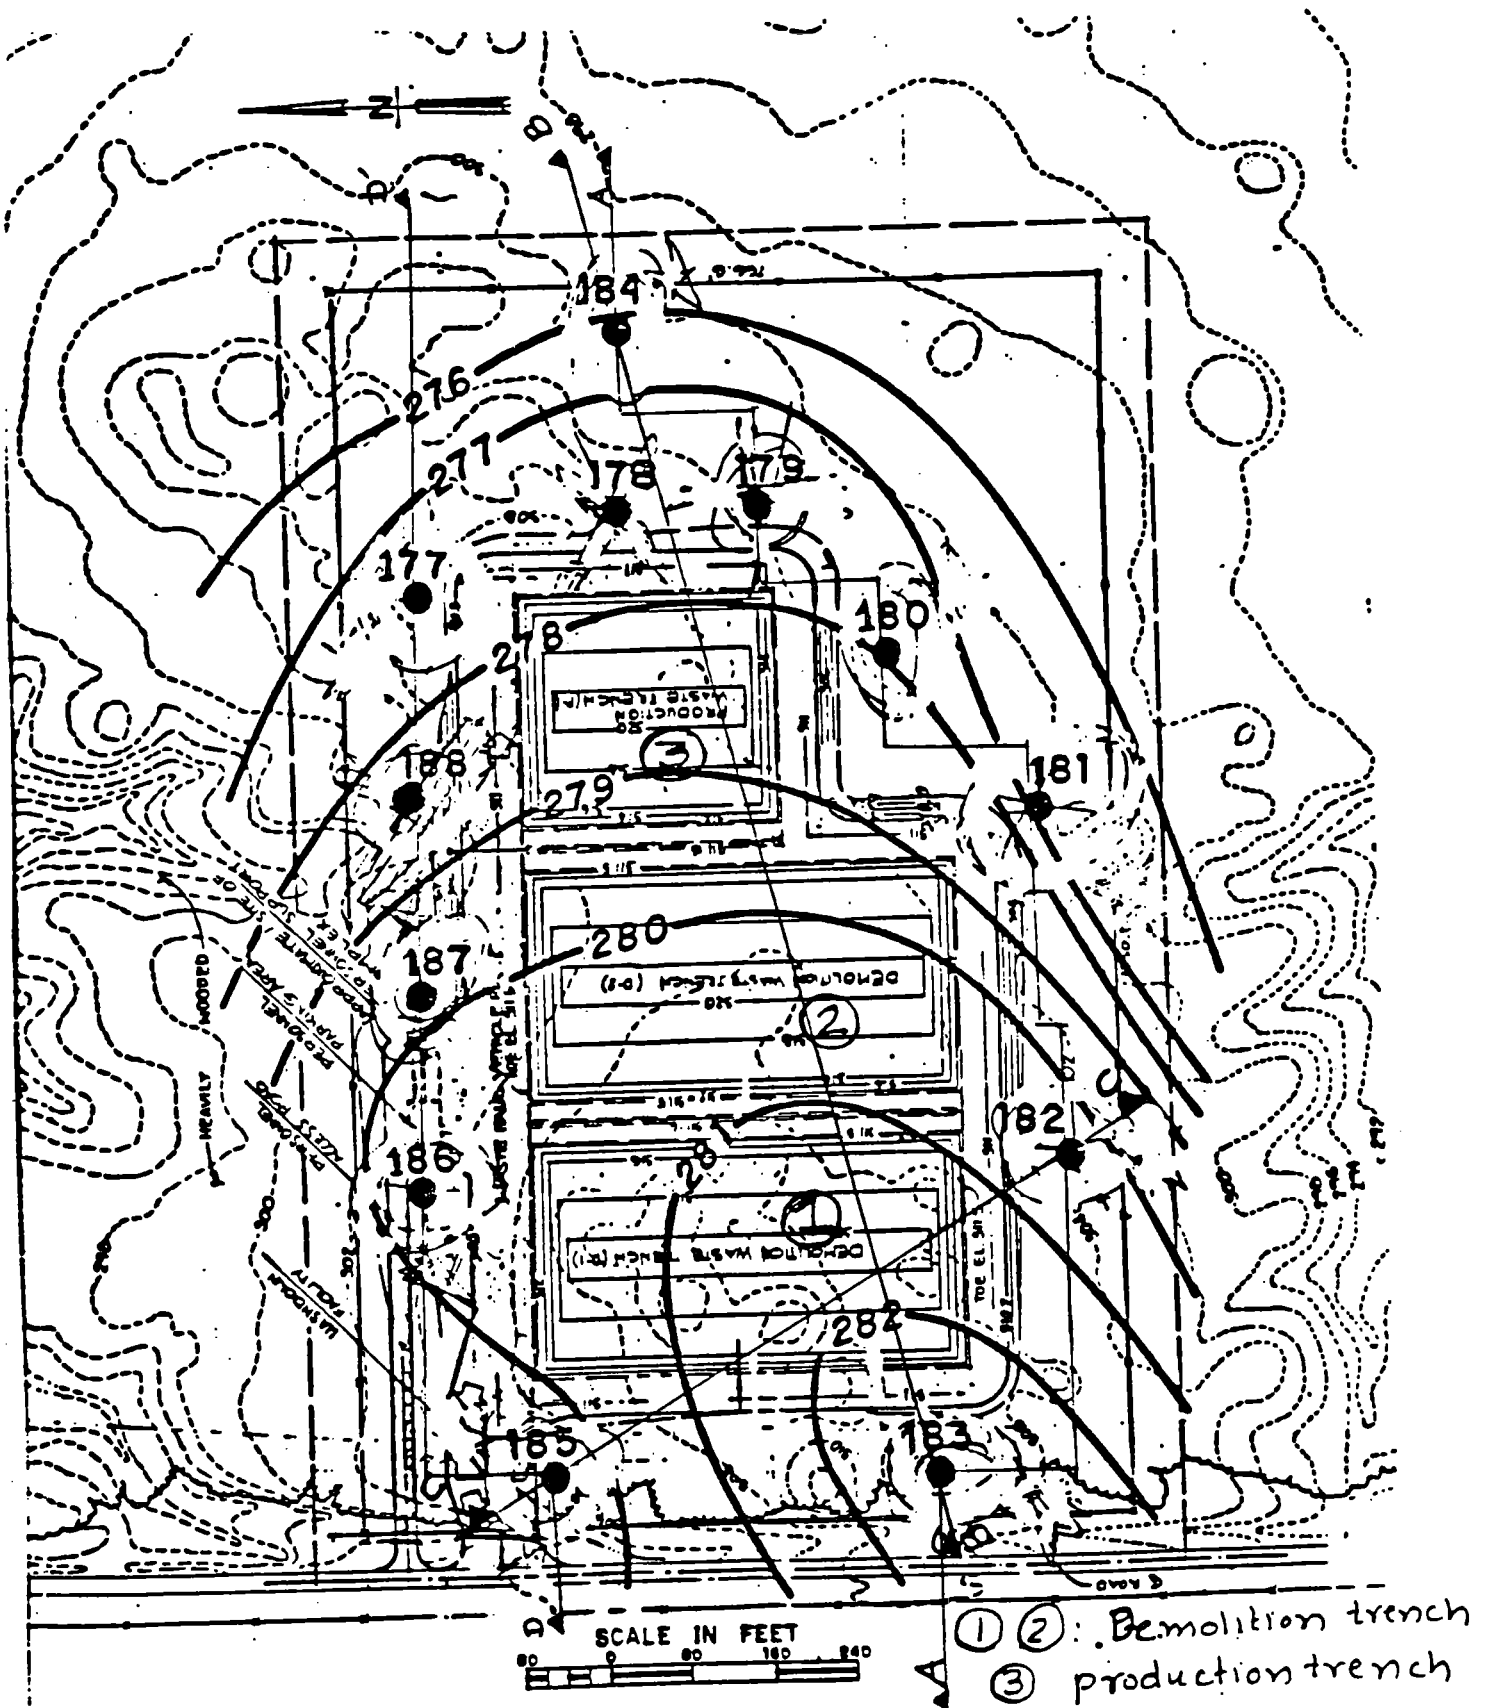
Figure 5. Landfill monitoring wells and water table (based on December, 1984 readings)

This well is inadequate because the excessive length of the sand packs (39 feet) causes excessive dilution which greatly decreases the ability of Well 184 to detect contaminants in the uppermost aquifer (Figure 8). Due to its location (downgradient of Well 178), Well 184 is not a necessary monitor well in this monitoring system (Figure 5).

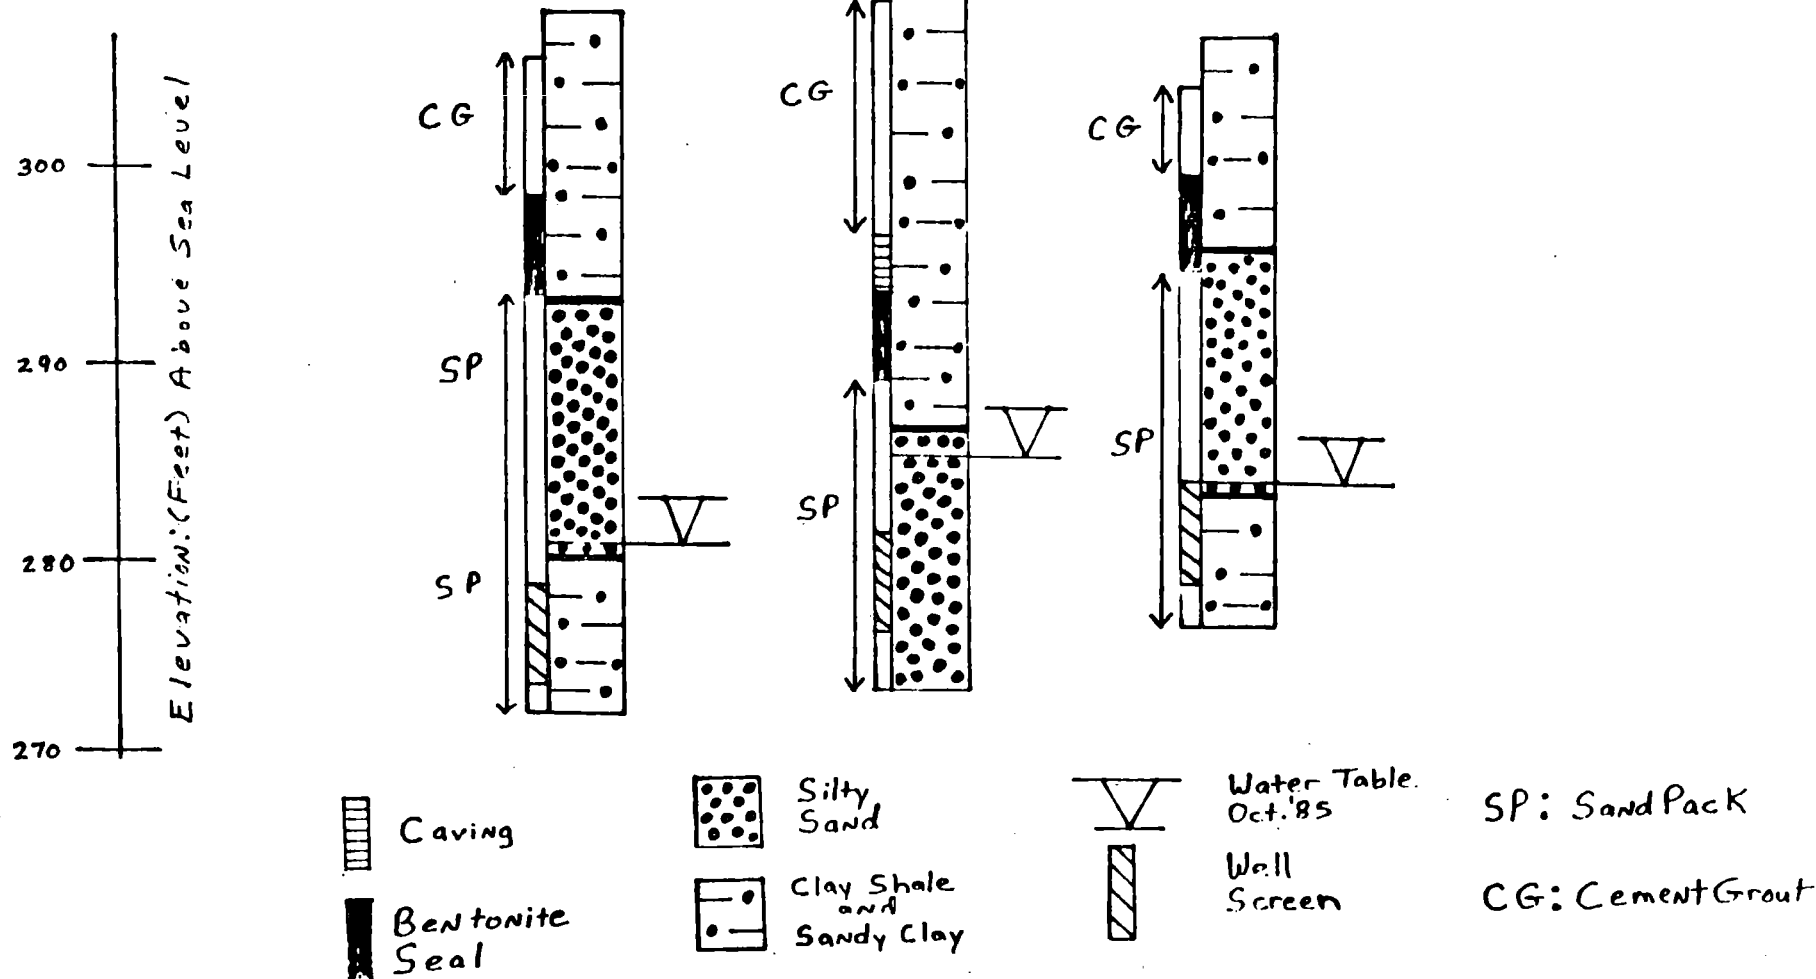
Figure 9. : 1985 Landfill PBA, C-C' Geologic Cross-section with Water Levels, October, 1985.

This well is inadequate because it yields abnormal water quality data (abnormally higher pH levels) compared with the other wells at the site. The pH values are an important parameter for determining groundwater contamination. Improper pH is likely to lead to wrong conclusions regarding metal concentrations and contamination. It also affects the solubility of the metals being monitored. The higher pH cannot be attributed to the lithology, soil chemistry, and natural variation. Since no waste was placed in the Landfill until October 1985, the pH level could not be affected by the contents of the Landfill. During four quarters of monitoring, the pH varied from 12.0 to 11.7 (see Table 1). The average pH at this site is 6.92. In addition, this well exhibited several fold higher barium content than the other wells and yielded turbid samples during the October inspection. The evidence indicates that the well does not represent natural groundwater quality and the well has been damaged, improperly installed or developed.

The high pH at this well can be attributed to dissolution of the cement grout which seals the annular space. The dissolution indicates an inadequate annular seal which results in an inadequate monitoring well and inaccurate groundwater quality data, especially background quality.

This well is inadequate because it yields abnormal groundwater quality samples. This well exhibited abnormal fluctuation of the pH levels (6.4 to 11.2) which is an unusual phenomenon not occurring naturally in groundwater. Only two samples were obtained during four quarters of sampling which are not enough samples for statistical comparison. In addition, the PBA's consultant, Ford Thorton Norton & Associates, in the December 1984 report indicated that the casing is at a 20° angle and the well has been damaged. This well has also yielded very turbid samples. The high pH can be attributed to dissolution of the cement grout which indicates an inadequate annular seal, inaccurate water quality data, and inaccurate background water quality data. Data from this well should not be utilized to determine groundwater quality, especially background quality.
